Manhole Inspection Summary

Manhole # S47II_032MH

Location Address: **Oliver St**

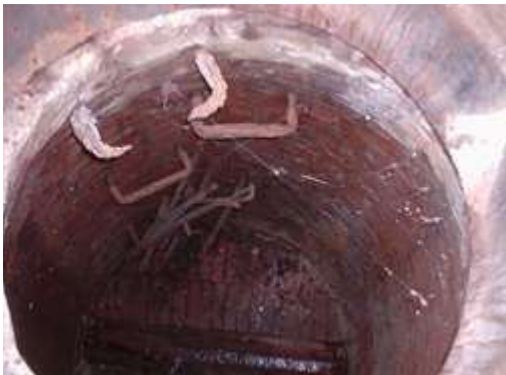
Defect 1

Condition: ☐ Sound ☐ Cracked ☐ Root Intrusion ☐ Loose Brick ☒ **Deteriorated**

Deterioration

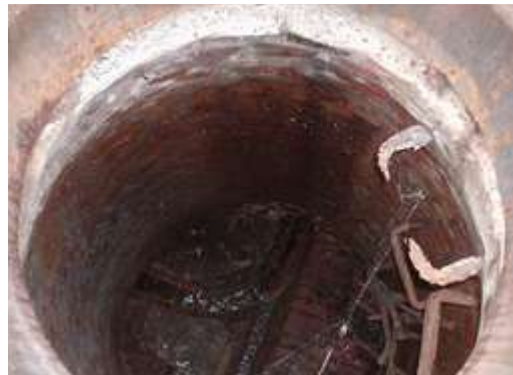
Defect 2

Infiltration: ☐ None ☒ **Joint** ☐ Cracks ☐ Mortar ☐ Roots ☐ Wall

Infiltration

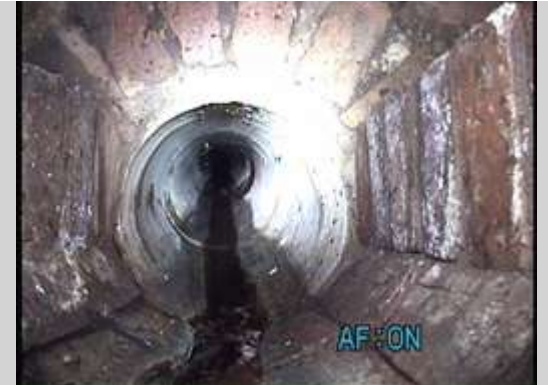
12 O'Clock Outflow

8 in. Circular Gravity Sewer
Pipe Out @ 12 O'Clock

Pipe Height: **8.4** (in.) Rod and Bar (Angled)
Pipe Material: **Clay** ☐ Pipe Lined
Invert Depth: **9.00** (ft.) Flow Characteristics: **Fast**
Deposits: ☒ None ☐ Mud ☐ Sludge ☐ Debris ☐ Grease
Silt Depth: (in.) Deposits Extent:
Infiltration: **None** Pipe Seal Cond: **Sound**

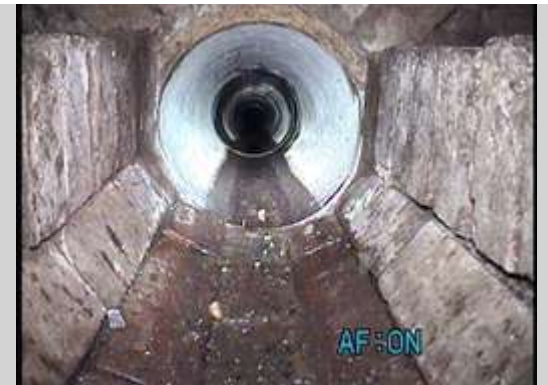
6 O'Clock Inflow

8 in. Circular Gravity Sewer
Pipe In @ 6 O'Clock

Pipe Height: **8.4** (in.) Rod and Bar (Angled)
Pipe Material: **Clay** ☐ Pipe Lined
Invert Depth: **8.45** (ft.) Flow Characteristics: **Slow**
Deposits: ☒ None ☐ Mud ☐ Sludge ☐ Debris ☐ Grease
Silt Depth: (in.) Deposits Extent:
Infiltration: **None** Pipe Seal Cond: **Sound**

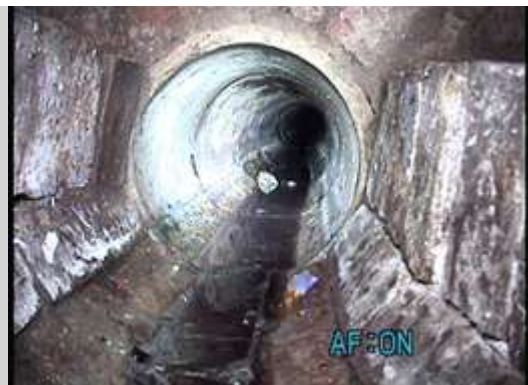
9 O'Clock Inflow

Pipe In @ 9 O'Clock

Infiltration: **None** Pipe Seal Cond: **Sound**
